**Flood Control Project Maintenance  
Levee Inspections**

## Maintenance Issue Types Only, Levee Inspection Report By Mile - Spring 2018

### Reclamation District No. 2063 Crows Landing

Waterway	Bank	Unit Miles	Inspection Start/End	Inspector
Unit No. 01 San Joaquin River	Right	10.44	03/27/2018 03/27/2018	Richard Willoughby

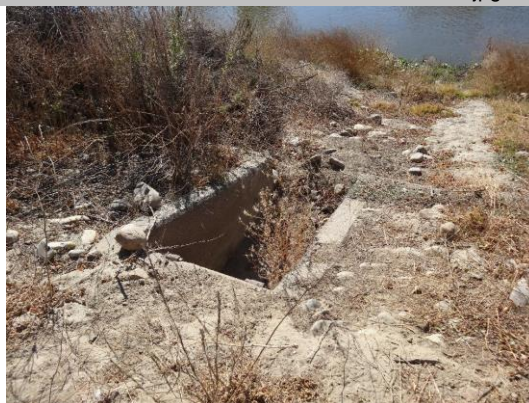
Photo 1 of 3 : UCIP\_SP\_2018\_24435\_43484.jpg

WS view: U shaped headwall outlet structure 70 ft off the levee center.

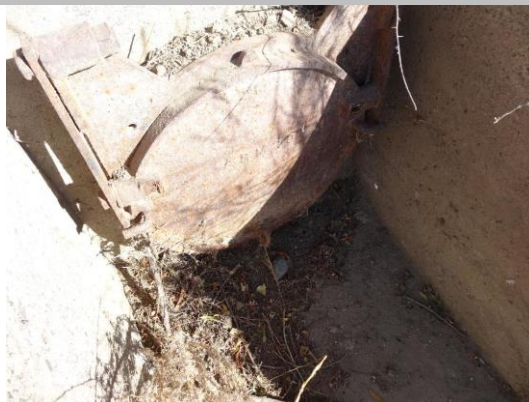
Photo 2 of 3 : UCIP\_SP\_2018\_24435\_43483.jpg

WS view: U shaped headwall outlet structure and pipe with flap gate.

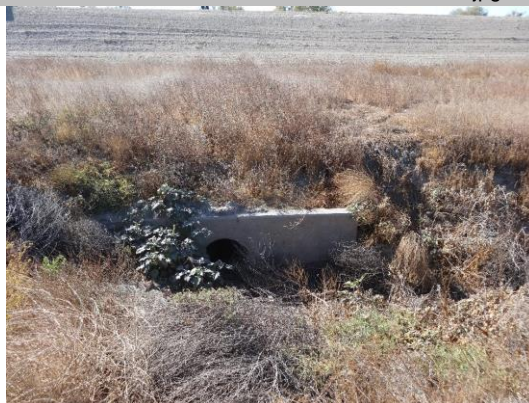
Photo 3 of 3 : UCIP\_SP\_2018\_24435\_43482.jpg

LM Start	2.62	Rating **	M	Issue No.	67 (cont)	
LM End	2.62	Issue Type +	Ma	Location *		
Category	Supplemental			GPS Latitude/Longitude		
				Start	End	
Item	DWR UCIP LMA Responsibility			37.448233 °	37.448233 °	
				-121.026521 °	-121.026521 °	
DWR ID						
Comment Code						
Inspector Comment						
FS_ID:24435 DS_ID:22086 EP_NO: N/A Repair Type: Non-Urgent Crossing Status: Found UCIP Comments: Both pipe ends 70 ft off the levee center.Clearing and cleaning of inlet/outlet pipe needed. FIELD_STRUCT_DESC: 24-inch corrugated metal gravity drainage pipe through the levee, 12 feet below the crown. Flap gate on the waterside (WS) end. Concrete headwall on each end. Installed by USACE in 1961. [Additional Reference(s): DWR Levee Log, 1992. USACE San Joaquin O&M Manual 6, September 1961, (HLM 2.65)]. FS Date: 11/5/2013

LS view: concrete headwall with CMP 70 ft off the levee center.

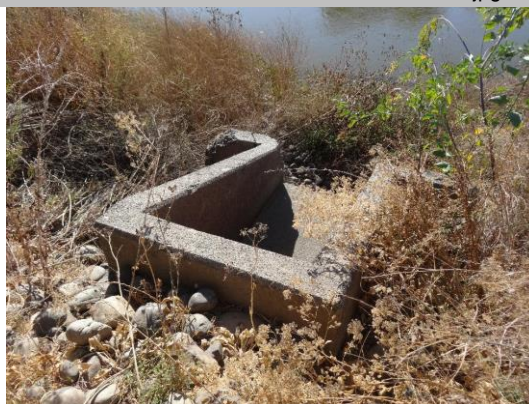
Photo 1 of 3 : UCIP\_SP\_2018\_25023\_45102.jpg

LM Start	2.68	Rating **	A/W	Issue No.	68
LM End	2.68	Issue Type +	Ma	Location *	
Category	Supplemental			GPS Latitude/Longitude	
				Start	End
Item	DWR UCIP LMA Responsibility			37.447475 °	37.447475 °
				-121.026017 °	-121.026017 °
DWR ID					
Comment Code					
Inspector Comment					
FS_ID:25023					
DS_ID:22087					
EP_NO: N/A					
Repair Type: No Action Needed					
Crossing Status: Found					
UCIP Comments: Both pipe ends about 85 feet off the levee center.					
FIELD_STRUCT_DESC: 24-inch corrugated metal gravity drainage pipe					
through the levee, 20.3 feet below the crown. Flap gate on the					
waterside (WS) end. Concrete headwall on each end. Installed by					
USACE in 1961. [Additional Reference(s): DWR Levee Log, 1992.					
USACE San Joaquin O&M Manual 6, September 1961, (HLM 2.71)].					
FS Date: 11/5/2013

WS view: U typed concrete headwall on river bank.

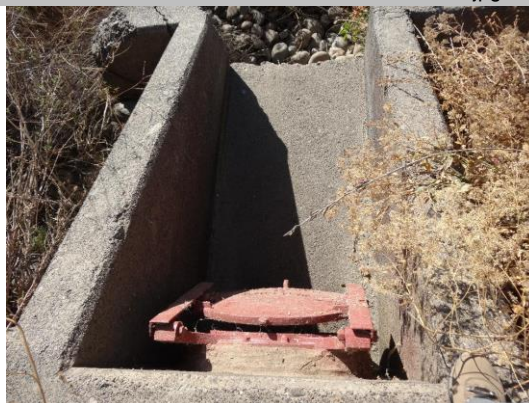
Photo 2 of 3 : UCIP\_SP\_2018\_25023\_45101.jpg

WS view: pipe, flap gate, and concrete headwall on river bank.

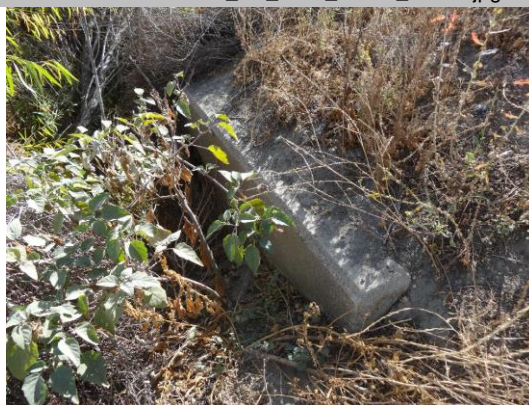
Photo 3 of 3 : UCIP\_SP\_2018\_25023\_45100.jpg

LS view: pipe and concrete headwall off the levee toe.

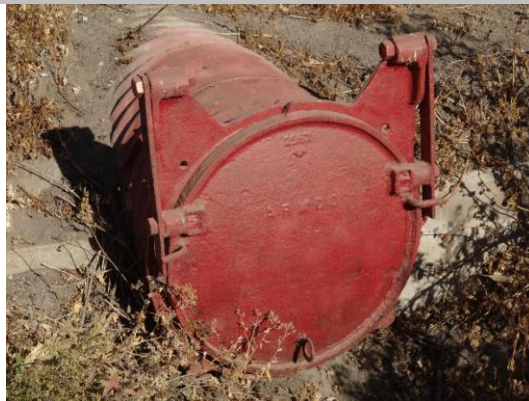
Photo 1 of 3 : UCIP\_SP\_2018\_24485\_43667.jpg

LM Start	3.64	Rating **	M	Issue No.	71
LM End	3.64	Issue Type +	Ma	Location *	
Category	Supplemental			GPS Latitude/Longitude	
				Start	End
Item	DWR UCIP LMA Responsibility			37.436845 °	37.436845 °
				-121.017826 °	-121.017826 °
DWR ID					
Comment Code					
Inspector Comment					
FS_ID:24485					
DS_ID:22093					
EP_NO: N/A					
Repair Type: Non-Urgent					
Crossing Status: Found					
UCIP Comments: - new flap gate on waterside.- cleaning and clearing of inlet box needed.					
FIELD_STRUCT_DESC: 24-inch corrugated metal gravity drainage pipe through the levee, 12 feet below the crown. Flap gate and concrete saddle on the waterside (WS) end. Concrete drop inlet box on the landside (LS) end. Installed by USACE in 1961. [Additional Reference(s): DWR Levee Log, 1992. USACE San Joaquin O&M Manual 6, September 1961, (HLM 3.69)].					
FS Date: 11/5/2013

WS view: pipe, flap gate, and concrete saddle on levee slope

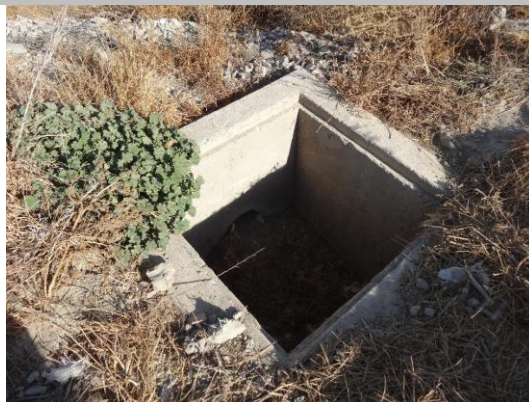
Photo 2 of 3 : UCIP\_SP\_2018\_24485\_43666.jpg

LS view: concrete drop inlet box on levee toe.

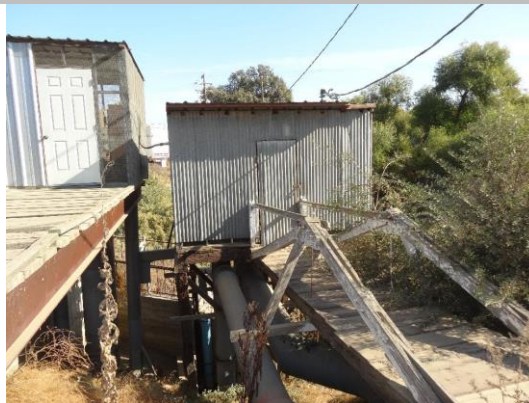
Photo 1 of 3 : UCIP\_SP\_2018\_24603\_43860.jpg

FS\_ID:24603  
DS\_ID:22100  
EP\_NO: 6721  
Repair Type: No Action Needed  
Crossing Status: Found  
UCIP Comments: - Overhead power line.- looks new inlet pipes in pumphouse.  
FIELD\_STRUCT\_DESC: [Vivian Slough Pumping Plant] 1 of 3: 18-inch steel drainage discharge pipe through the levee, 2 feet below the crown. Pumps in a pump house and timber walkway on the landside (LS). Riser on the waterside (WS). (Plans to install a 30-horsepower pump and discharge pipe at existing pumping plant authorized under Permit No. 6721, 1969 - Reclamation District No. 2063. Plans to replace two 20-inch pipes through the levee at existing pumping plant authorized under Permit No. 6721-A, 1980 - Reclamation District No. 2063). [Additional Reference(s): DWR Levee Log, 1992, two 20-inch and one 22-inch pipes referenced. USACE San Joaquin O&M Manual 6, September 1961, (HLM 4.23), two 20-inch pipes referenced].  
FS Date: 11/6/2013

LS view: walkway to pump, pump house (right), and pipes on levee

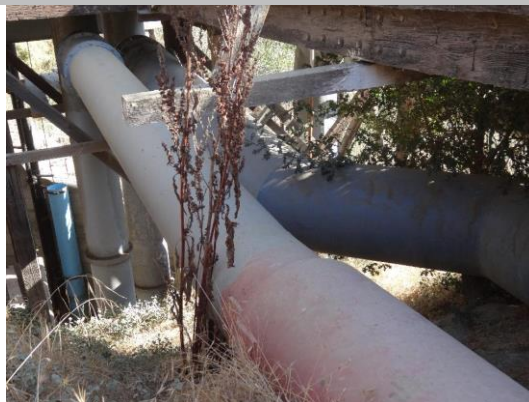
Photo 2 of 3 : UCIP\_SP\_2018\_24603\_43862.jpg

LS view: pipes (18" pipe - left, 20" pipe- right) under walkway and pump house on levee slope.

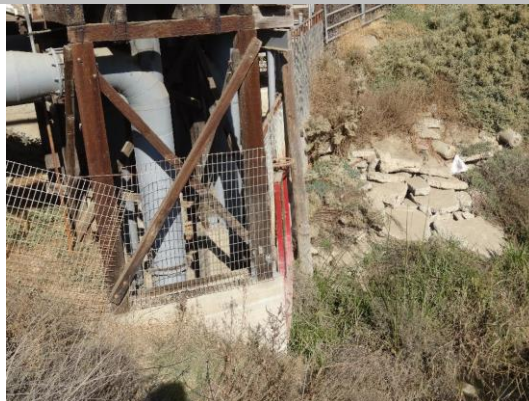
Photo 3 of 3 : UCIP\_SP\_2018\_24603\_43861.jpg

LS view: intake sump under pump house, and pipes in drainage ditch.

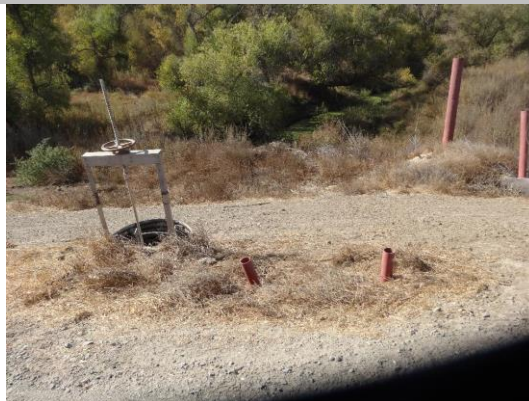
Photo 1 of 3 : UCIP\_SP\_2018\_25026\_45115.jpg

FS\_ID:25026  
DS\_ID:22120  
EP\_NO: 6721  
Repair Type: No Action Needed  
Crossing Status: Found  
UCIP Comments: New intake pipe to pump. Pump house on concrete sump in drainage ditch.  
FIELD\_STRUCT\_DESC: [Vivian Slough Pumping Plant] 2 of 3: 20-inch steel drainage discharge pipe through the levee, 2 feet below the crown. Pumps in a pump house and timber walkway on the landside (LS). Riser on the waterside (WS). (Plans to install a 30-horsepower pump and discharge pipe at existing pumping plant authorized under Permit No. 6721, 1969 - Reclamation District No. 2063. Plans to replace two 20-inch pipes through the levee at existing pumping plant authorized under Permit No. 6721-A, 1980 - Reclamation District No. 2063). [Additional Reference(s): DWR Levee Log, 1992, two 20-inch and one 22-inch pipes referenced. USACE San Joaquin O&M Manual 6, September 1961, (HLM 4.23), two 20-inch pipes referenced].

WS view: air vents (red) on levee slope.

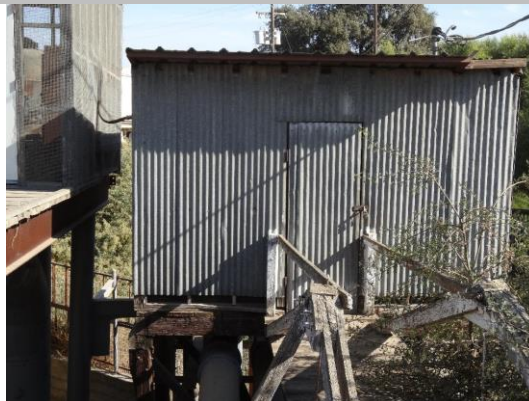
Photo 1 of 3 : UCIP\_SP\_2018\_25027\_45120.jpg

FS\_ID:25027  
DS\_ID:22121  
EP\_NO: 6721  
Repair Type: No Action Needed  
Crossing Status: Found  
UCIP Comments: - new intake pipe to the pump.- overhead power line.  
FIELD\_STRUCT\_DESC: [Vivian Slough Pumping Plant] 3 of 3: 16-inch steel drainage discharge pipe through the levee, 3.6 feet below the crown. Pumps in a pump house and timber walkway on the landside (LS). Riser on the waterside (WS). (Plans to install a 30-horsepower pump and discharge pipe at existing pumping plant authorized under Permit No. 6721, 1969 - Reclamation District No. 2063. Plans to replace two 20-inch pipes through the levee at existing pumping plant authorized under Permit No. 6721-A, 1980 - Reclamation District No. 2063). [Additional Reference(s): DWR Levee Log, 1992, two 20-inch and one 22-inch pipes referenced. USACE San Joaquin O&M Manual 6, September 1961, (HLM 4.23), two 20-inch pipes referenced].  
FS Date: 11/6/2013

LS view: walkway to pump and pump house on levee slope.

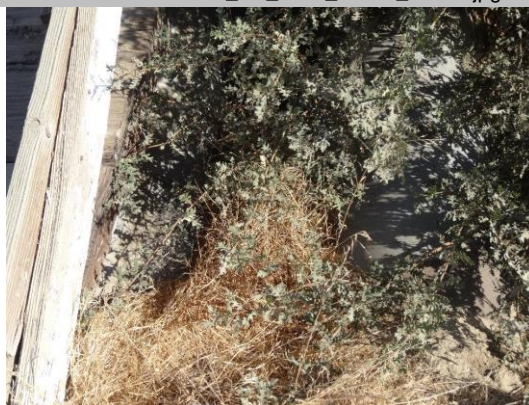
Photo 2 of 3 : UCIP\_SP\_2018\_25027\_45119.jpg

LS view: walkway to pump and pipe (right) on levee slope.

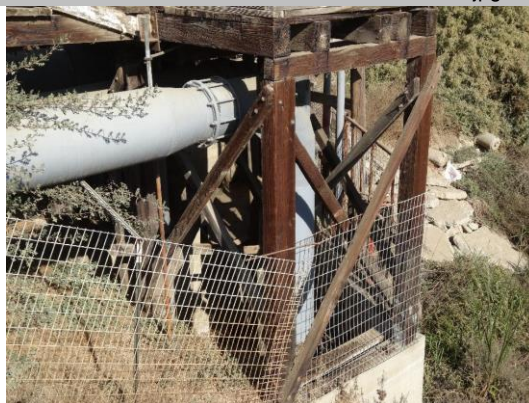
Photo 3 of 3 : UCIP\_SP\_2018\_25027\_45118.jpg

LS view: intake pipes and pump house on concrete sump in drainage ditch.

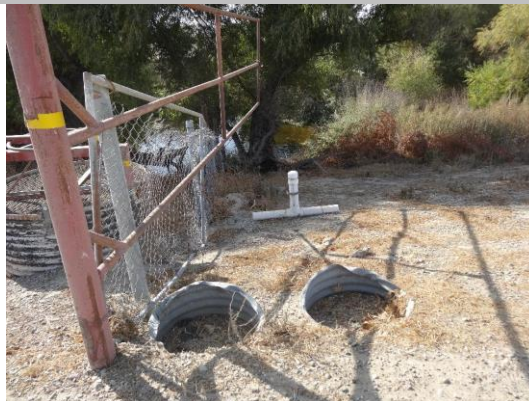
Photo 1 of 3 : UCIP\_SP\_2018\_24651\_44005.jpg

FS\_ID:24651  
DS\_ID:22124  
EP\_NO: N/A  
Repair Type: Non-Urgent  
Crossing Status: Found  
UCIP Comments: 10/27/2017 This structure is inspected annually under the Structure and Channel Summer Inspection (part of the Levee Inspection Program) conducted by the DWR Flood Project Integrity and Inspection Branch (FPIIB). (DWR UCIP - O. Magana)  
- working during field inspection.- blocked siphon breaker.  
FIELD\_STRUCT\_DESC: 1 of 2: 16-inch steel drainage discharge pipe through the levee, 3.5 feet below the crown. Siphon breaker in a corrugated metal pipe (CMP) riser on the waterside (WS) slope. Flap gate on the WS end. Pump on a timber pile structure on the landside (LS). Timber walkway from levee to pump structure. [Additional Reference(s): DWR Levee Log, 1992. USACE San Joaquin O&M Manual 6, September 1961, (HLM 8.60)].  
FS Date: 11/6/2013

WS view: two siphon breakers in CMP risers on levee slope.

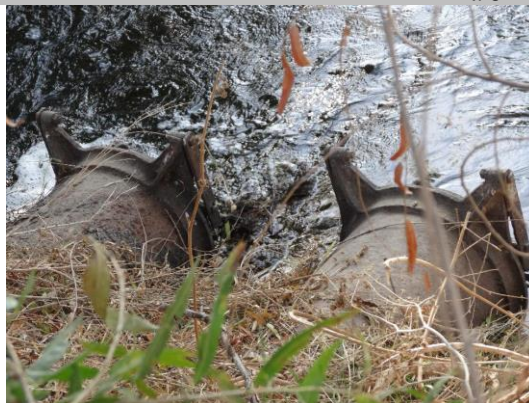
Photo 2 of 3 : UCIP\_SP\_2018\_24651\_44004.jpg

WS view: two flap gates on outfall pipe ends.

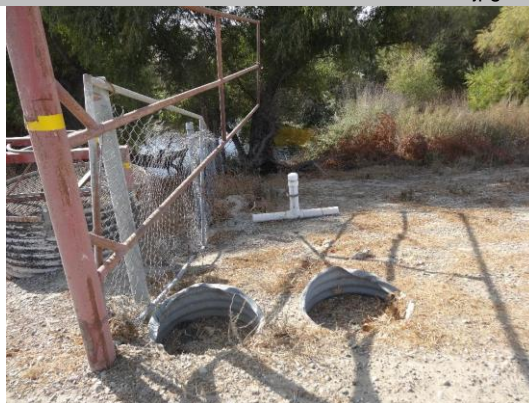
Photo 1 of 3 : UCIP\_SP\_2018\_24652\_44008.jpg

FS\_ID:24652  
DS\_ID:22112  
EP\_NO: N/A  
Repair Type: Non-Urgent  
Crossing Status: Found  
UCIP Comments: 10/27/2017 This structure is inspected annually under the Structure and Channel Summer Inspection (part of the Levee Inspection Program) conducted by the DWR Flood Project Integrity and Inspection Branch (FPIIB). (DWR UCIP - O. Magana)  
- working during field inspection.- blocked siphon breaker.  
FIELD\_STRUCT\_DESC: 2 of 2: 16-inch steel drainage discharge pipe through the levee, 3.5 feet below the crown. Siphon breaker in a corrugated metal pipe (CMP) riser on the waterside (WS) slope. Flap gate on the WS end. Pump on a timber pile structure on the landside (LS). Timber walkway from levee to pump structure. [Additional Reference(s): DWR Levee Log, 1992. USACE San Joaquin O&M Manual 6, September 1961, (HLM 8.60)].  
FS Date: 11/6/2013

WS view: two siphon breakers in CMP risers on levee slope.

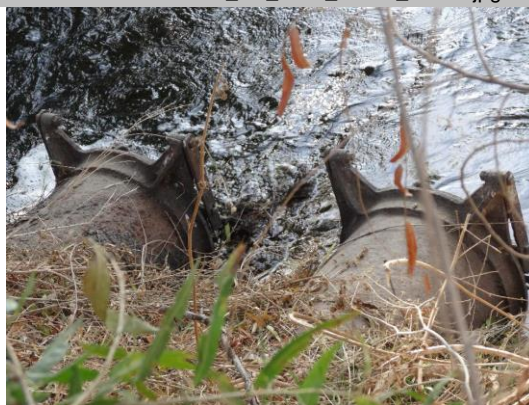
Photo 2 of 3 : UCIP\_SP\_2018\_24652\_44007.jpg

WS view: two flap gates on outfall pipe ends.

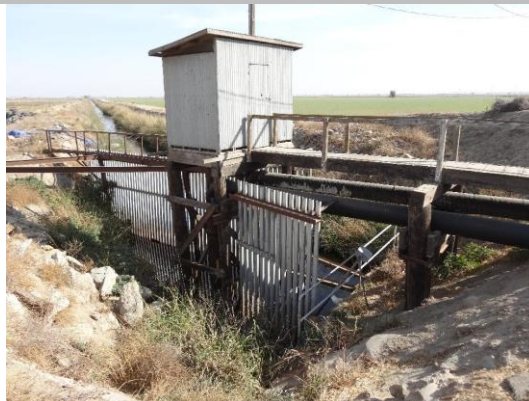
Photo 3 of 3 : UCIP\_SP\_2018\_24652\_44006.jpg

LS view: pipes under walkway to pump house.

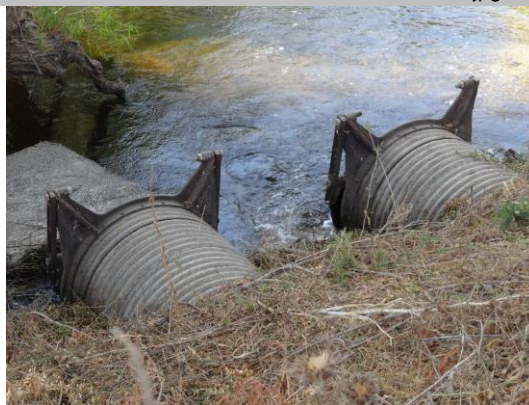
Photo 1 of 3 : UCIP\_SP\_2018\_24650\_44002.jpg

FS\_ID:24650  
DS\_ID:22113  
EP\_NO: N/A  
Repair Type: No Action Needed  
Crossing Status: Found  
UCIP Comments: 10/27/2017 This structure is inspected annually under the Structure and Channel Summer Inspection (part of the Levee Inspection Program) conducted by the DWR Flood Project Integrity and Inspection Branch (FPIIB). (DWR UCIP - O. Magana)  
Working during field inspection.  
FIELD\_STRUCT\_DESC: [Reclamation District No. 2063 Pumping Plant] 1 of 2: 42-inch corrugated metal gravity drainage pipe through the levee, 18 feet below the crown. Slide gate in a corrugated metal pipe (CMP) riser on the waterside (WS) slope. Flap gate, concrete saddle, and apron on the WS end. Concrete headwall on the landside (LS) end. [Additional Reference(s): DWR Levee Log, 1992. USACE San Joaquin O&M Manual 6, September 1961, (HLM 8.60)].  
FS Date: 11/6/2013

WS view: two flap gates on outfall pipe ends.

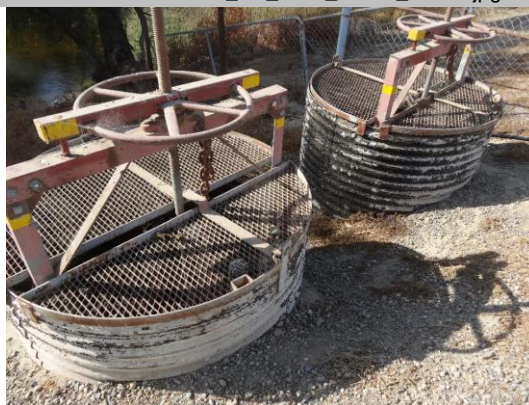
Photo 2 of 3 : UCIP\_SP\_2018\_24650\_44001.jpg

WS view: two slide gates in CMP risers on levee slope.

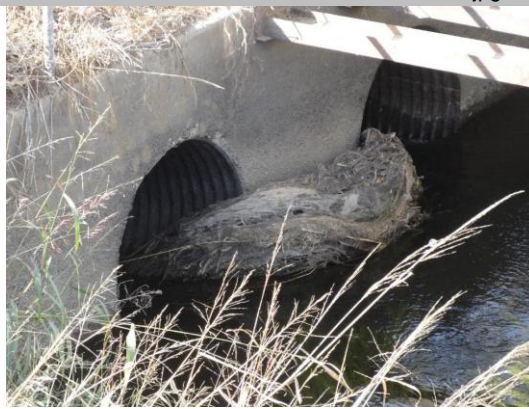
Photo 3 of 3 : UCIP\_SP\_2018\_24650\_44000.jpg

LS view: drainage pipes under walkway in drainage ditch.

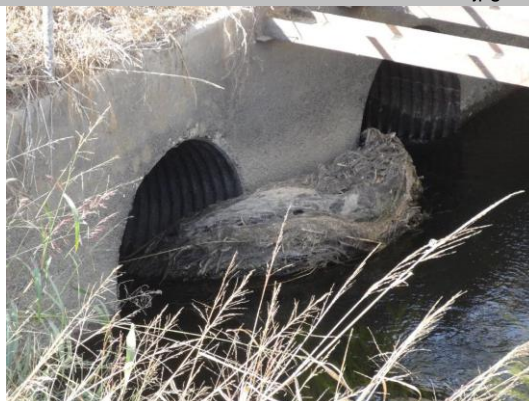
Photo 3 of 3 : UCIP\_SP\_2018\_24636\_43963.jpg

LS view: drainage pipes under walkway in drainage ditch.

Comment Code					
Inspector Comment					
FS_ID:24636 DS_ID:22125 EP_NO: N/A Repair Type: No Action Needed Crossing Status: Found UCIP Comments: 10/27/2017 This structure is inspected annually under the Structure and Channel Summer Inspection (part of the Levee Inspection Program) conducted by the DWR Flood Project Integrity and Inspection Branch (FPIIB). (DWR UCIP - O. Magana) - working during field inspection. FIELD_STRUCT_DESC: [Reclamation District No. 2063 Pumping Plant] 2 of 2: 42-inch corrugated metal gravity drainage pipe through the levee, 18 feet below the crown. Slide gate in a corrugated metal pipe (CMP) riser on the waterside (WS) slope. Flap gate, concrete saddle, and apron on the WS end. Concrete headwall on the landside (LS) end. [Additional Reference(s): DWR Levee Log, 1992. USACE San Joaquin O&M Manual 6, September 1961, (HLM 8.60)]. FS Date: 11/6/2013

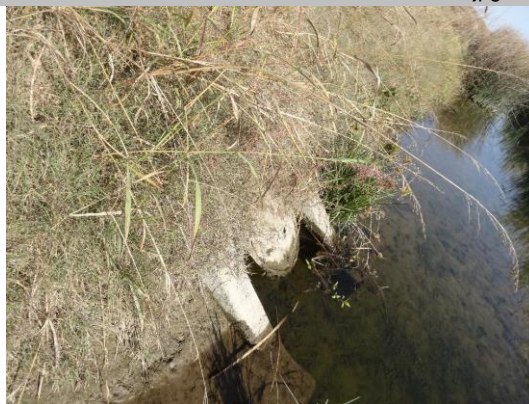
Photo 2 of 3 : UCIP\_SP\_2018\_51825\_43983.jpg

WS view: U type headwall and flap gate visible on the bank of the water channel.

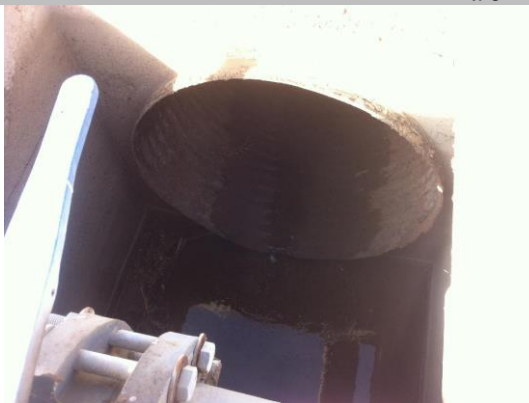
Photo 1 of 3 : UCIP\_SP\_2018\_24644\_43986.jpg

LM Start	9.94	Rating **	A/W	Issue No.	91
LM End	9.94	Issue Type +	Ma	Location *	
Category	Supplemental			GPS Latitude/Longitude	
				Start	End
Item	DWR UCIP LMA Responsibility			37.390563 °	37.390563 °
				-120.950329 °	-120.950329 °
DWR ID					
Comment Code					
Inspector Comment					
FS_ID:24644 DS_ID:22116 EP_NO: N/A Repair Type: No Action Needed Crossing Status: Found UCIP Comments: - not very old structure. FIELD_STRUCT_DESC: 48-inch corrugated metal gravity drainage pipe through the levee and across the drainage ditch on the waterside (WS), 6 feet below the crown. Slide gate and concrete box on the WS end. Concrete box on the landside (LS) end. Installed by USACE in 1961. [Additional Reference(s): DWR Levee Log, 1992. USACE San Joaquin O&M Manual 6, September 1961, (HLM 10.11)]. FS Date: 11/6/2013

WS view: CM pipe on outlet concrete box.

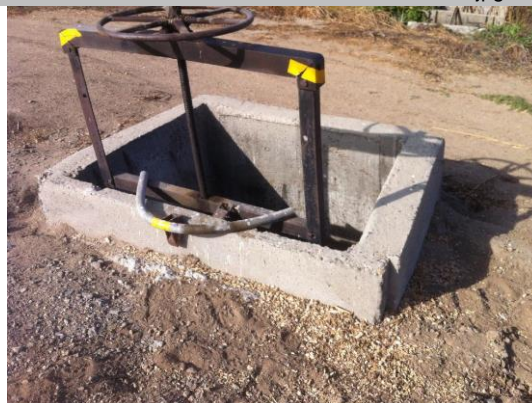
Photo 2 of 3 : UCIP\_SP\_2018\_24644\_43985.jpg

FS\_ID:24644  
DS\_ID:22116  
EP\_NO: N/A  
Repair Type: No Action Needed  
Crossing Status: Found  
UCIP Comments: - not very old structure.  
FIELD\_STRUCT\_DESC: 48-inch corrugated metal gravity drainage pipe through the levee and across the drainage ditch on the waterside (WS), 6 feet below the crown. Slide gate and concrete box on the WS end. Concrete box on the landside (LS) end. Installed by USACE in 1961. [Additional Reference(s): DWR Levee Log, 1992. USACE San Joaquin O&M Manual 6, September 1961, (HLM 10.11)].  
FS Date: 11/6/2013

LM Start	<b>9.94</b>	Rating **	A/W	Issue No.	<b>91 (cont)</b>
LM End	<b>9.94</b>	Issue Type +	Ma	Location *

LS view: CM pipe with slide gate on inlet concrete box.

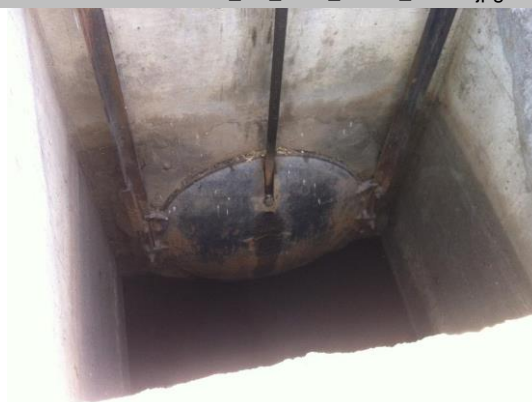
Photo 3 of 3 : UCIP\_SP\_2018\_24644\_43984.jpg

LS view: inside view of slide gate in concrete box.
